1 RV Inspection

Status Upon Start

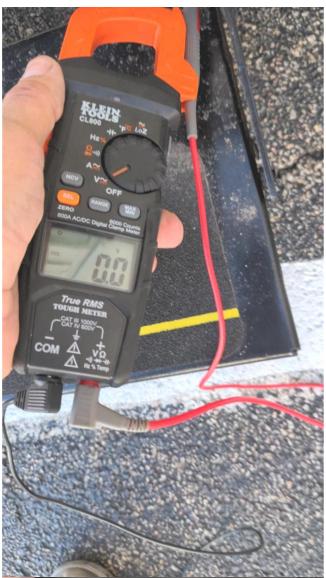
2.2 Item 1 (Picture) steps voltage

Less than 5.0 volts AC was found on the RV steps during the performance of the Hot Skin Test.

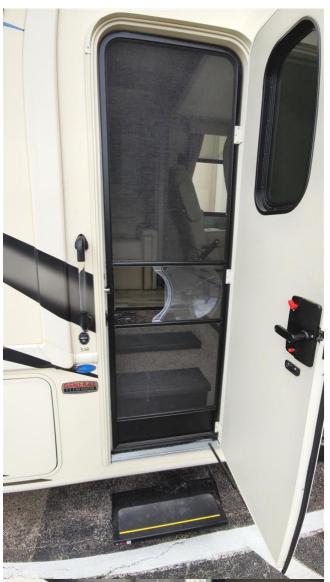
6.4 Item 1 (Picture) screen door closed

This may be a feature of the coach by design of the manufacturer, however the inspector recommends that the door mechanism be evaluated by a qualified RV technician for any issues.

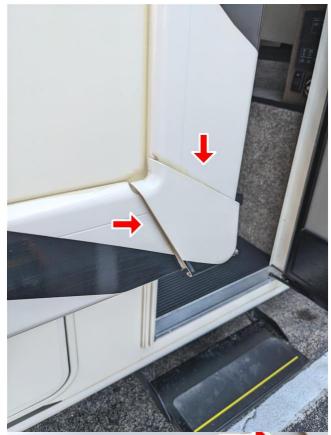
9.6 Item 2 (Picture)

(2) The lower front T-molding corner is loose and the adhesive is failing. This is a potential source of water intrusion, or it could be lost during travel. The inspector recommends that the trim be repaired by a qualified RV technician.

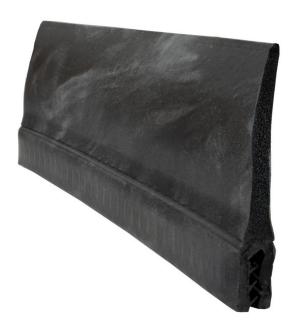
9.7 Item 1 (Picture)
Typical Slideout Sweep Seal

The seal and sweep on the curbside roof slide out is partially indented. The seal should be checked after every use for proper position.

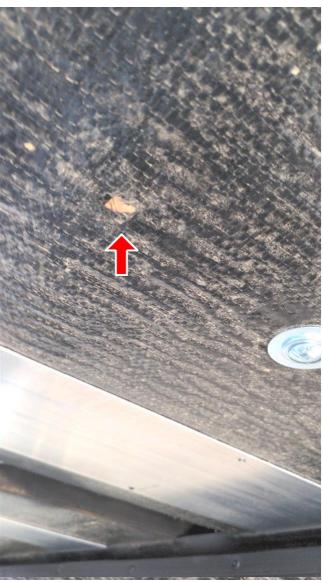
12.3 Item 2 (Picture) slide out floor small defect

There is a small defect in the center area of the slide out floor which could be a source of water intrusion. The inspector recommends that the area be addressed by a qualified RV technician and resealed.

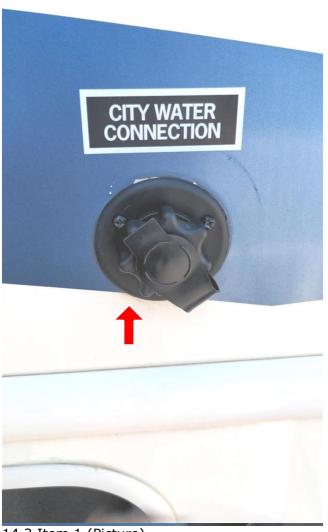
14.2 Item 1 (Picture) city water connection

While clearly labeled, the city water connection is black in color, while convention usually has it white in color. The inspector recommends the owner not confuse this inlet with the black tank flush inlet.

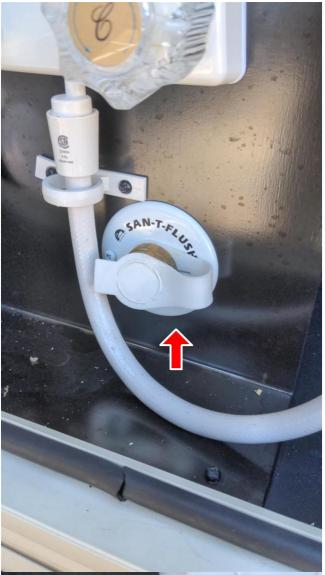
14.6 Item 1 (Picture) black tank flush valve

The black tank flush connection is white in color, when the convention is generally that the black tank flush is black. The inspector recommends that the owner be very familiar with operation of the flush and not have himself or others inadvertently connect a water hose thinking this is the city water inlet.

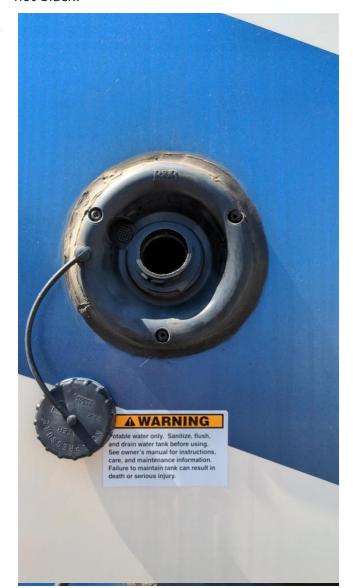
14.11 Item 1 (Picture) on board gravity water fill

Overview of the onboard tank fill. It is located street side on the rear of the coach sidewall. Again, convention has potable water inlets as white in color, not black

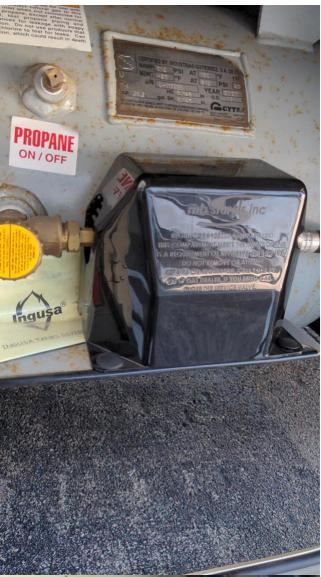
15.1 Item 1 (Picture) regulator inside cover

Overview of the LP tank hose(s) and regulator(s). There was a cover over the regulator which was secured by fasteners. Prior to first use the inspector recommends that the system be evaluated by a qualified RV technician for appropriateness of use.

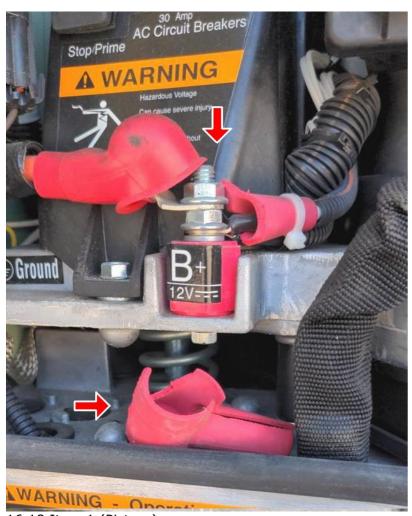
16.18 Item 1 (Picture) damaged electrical power covers

Overview of the generator. The generator electrical outlet has its rubber caps deteriorated and in lying in pieces at the bottom of the generator housing. The inspector recommends that these electrical connections be evaluated by a qualified RV technician prior to use. This is a life safety issue due to the risk of potential electrical shocks.

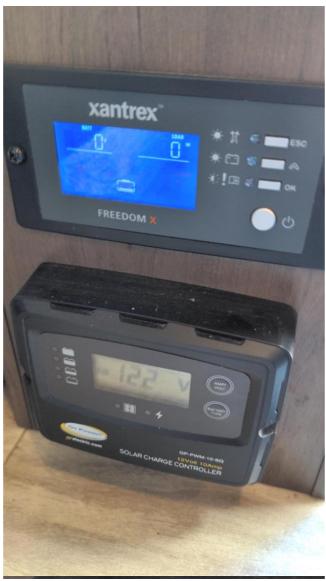
16.20 Item 1 (Picture) solar charge controller

Overview of the solar control panel. A solar controller is present at the entryway area, but no solar panels are installed on the roof.

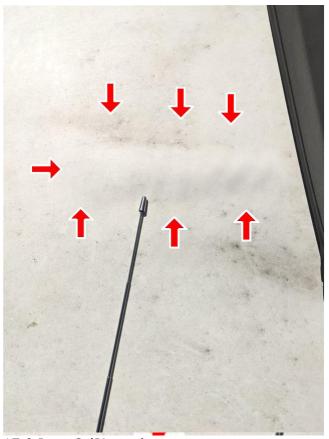
17.0 Item 3 (Picture)
Bubble in roof membrane

(2) There are multiple areas of isolated bubbles in the roof membrane. The inspector found no areas of softness or crunching to suggest water damage. While many manufacturers claim such findings to be normal, the inspector recommends that the roof be inspected by a qualified RV technician for defects.

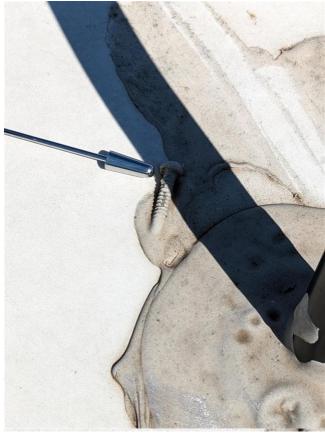
17.16 Item 2 (Picture) Screw in sealant

(2) A loose screw has been sealed into the sealant at the ladder base mount. The inspector recommends that the area be addressed by a qualified roof technician and the screw be removed and sealant be reapplied.

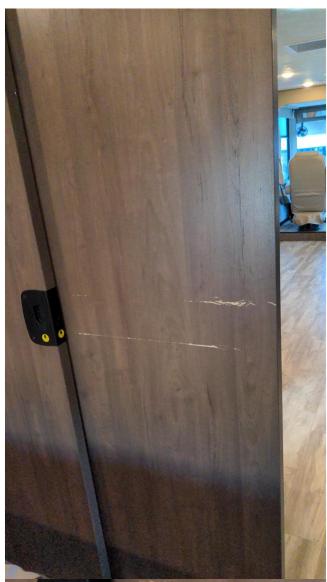
22.17 Item 1 (Picture) scratched door

The interior barn door set in the master bedroom do not operate properly. There are scratches on one of the doors, and the rear door does not go over the bracket on the bottom of the first door as it is supposed to. In addition the inspector could not identify any sort of locking mechanism to secure the door during travel. The door can be manipulated closed but the inspector recommends that the door alignment be assessed by a qualified RV technician.

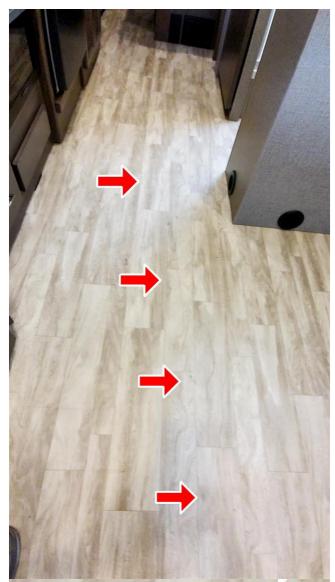
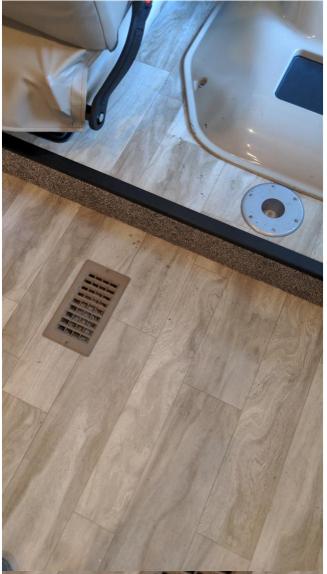
There are a couple of areas on the flooring that appear to have been stained or scraped with a black adhesive substance, and there is a long scratch beginning at the front of the kitchen counter toward the back of the stove. The stains should be amenable to cleaning.

22.19 Item 1 (Picture) floor scratch

22.19 Item 2 (Picture) floor adhesive

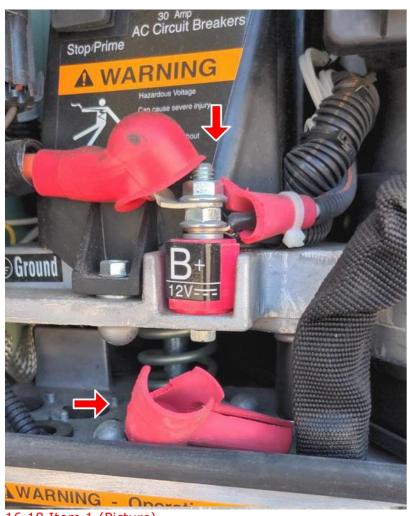
16.18 Item 1 (Picture) damaged electrical power covers

Overview of the generator. The generator electrical outlet has its rubber caps deteriorated and in lying in pieces at the bottom of the generator housing. The inspector recommends that these electrical connections be evaluated by a qualified RV technician prior to use. This is a life safety issue due to the risk of potential electrical shocks.

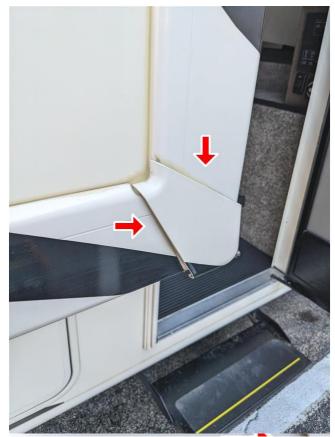
9.6 Item 2 (Picture)

(2) The lower front T-molding corner is loose and the adhesive is failing. This is a potential source of water intrusion, or it could be lost during travel.. The inspector recommends that the trim be repaired by a qualified RV technician.

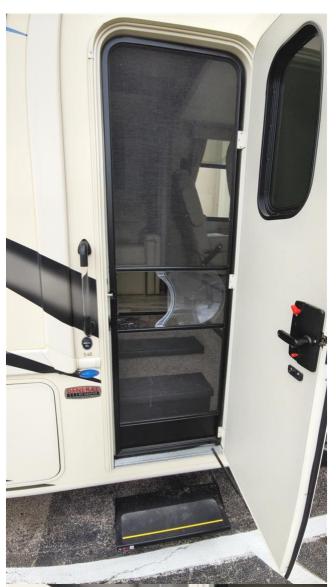
6.4 Item 1 (Picture) screen door closed

This may be a feature of the coach by design of the manufacturer, however the inspector recommends that the door mechanism be evaluated by a qualified RV technician for any issues.

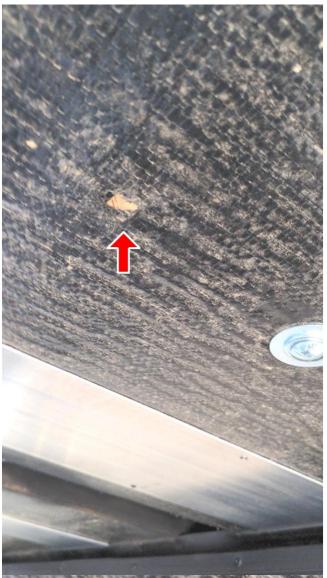
12.3 Item 2 (Picture) slide out floor small defect

There is a small defect in the center area of the slide out floor which could be a source of water intrusion. The inspector recommends that the area be addressed by a qualified RV technician and resealed.

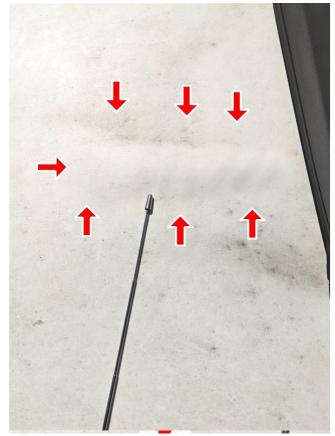
17.0 Item 3 (Picture)
Bubble in roof membrane

(2) There are multiple areas of isolated bubbles in the roof membrane. The inspector found no areas of softness or crunching to suggest water damage. While many manufacturers claim such findings to be normal, the inspector recommends that the roof be inspected by a qualified RV technician for defects.

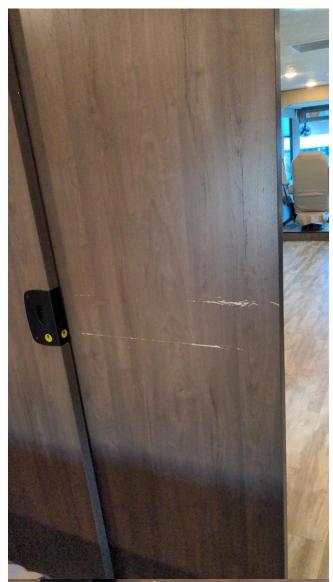
22.17 Item 1 (Picture) scratched door

recommends that the door alignment be assessed by a qualified RV technician.

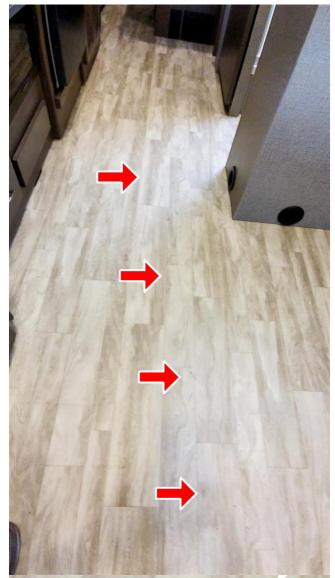
22.19 Item 1 (Picture) floor scratch

There are a couple of areas on the flooring that appear to have been stained or scraped with a black adhesive substance, and there is a long scratch beginning at the front of the kitchen counter toward the back of the stove. The stains should be amenable to cleaning.

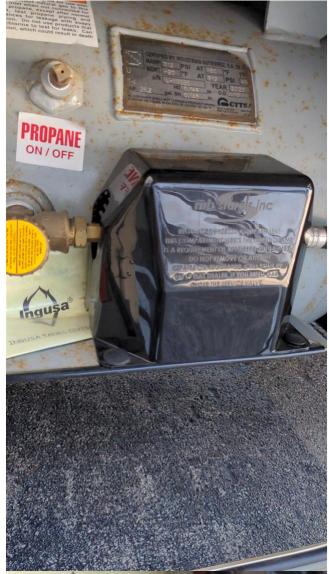
15.1 Item 1 (Picture) regulator inside cover

Overview of the LP tank hose(s) and regulator(s). There was a cover over the regulator which was secured by fasteners. Prior to first use the inspector recommends that the system be evaluated by a qualified RV technician for appropriateness of use.

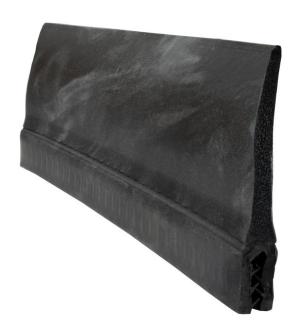
9.7 Item 1 (Picture) Typical Slideout Sweep Seal

The seal and sweep on the curbside roof slide out is partially indented. The seal should be checked after every use for proper position.

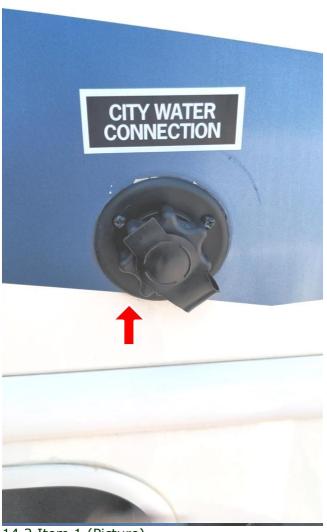
14.2 Item 1 (Picture) city water connection

While clearly labeled, the city water connection is black in color, while convention usually has it white in color. The inspector recommends the owner not confuse this inlet with the black tank flush inlet.

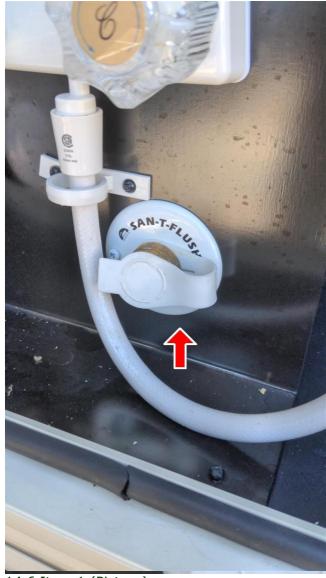
14.6 Item 1 (Picture) black tank flush valve

The black tank flush connection is white in color, when the convention is generally that the black tank flush is black. The inspector recommends that the owner be very familiar with operation of the flush and not have himself or others inadvertently connect a water hose thinking this is the city water inlet.
