1 RV Inspection

Status Upon Start

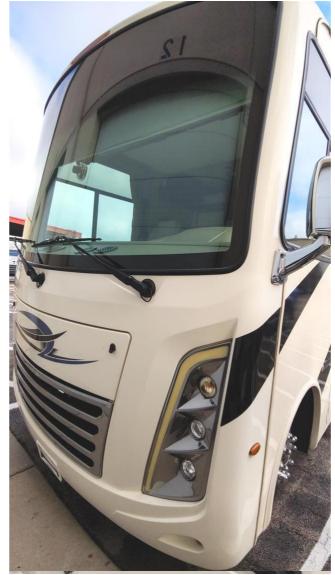
1.0 Item 2 (Picture) front upon arrival

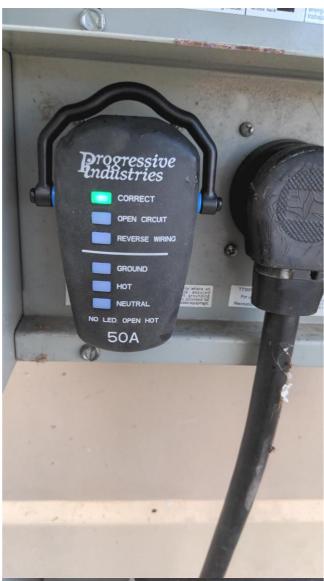
The shore power outlet was tested with a Progressive Industries portable tester module. No abnormal findings were discovered.

2.1 Item 1 (Picture) Shore Power Outlet Polarity

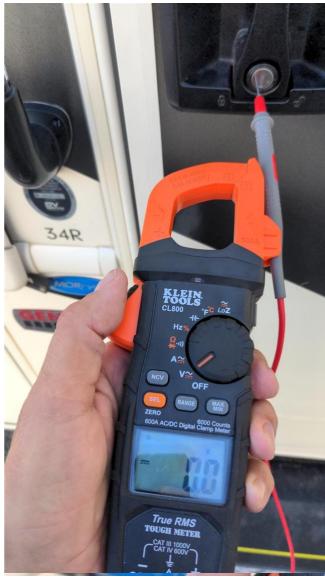
2.2 Item 2 (Picture) door voltage

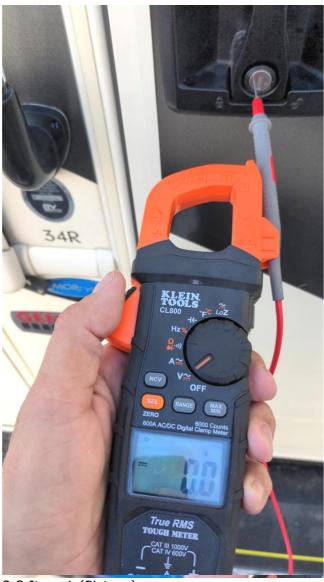
2.3 Item 1 (Picture)

Less than 5.0 volts AC was found on the RV handles during the performance of the Hot Skin Test.

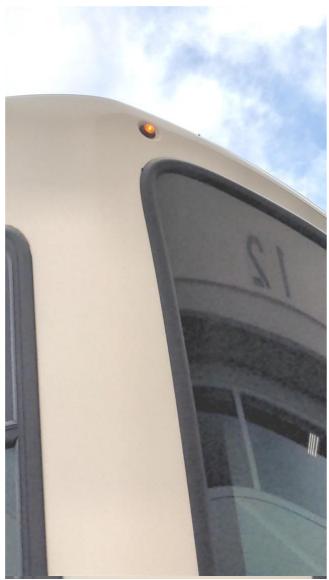
The front clearance lights all illuminate acceptably.

4.1 Item 1 (Picture) front clearance lights

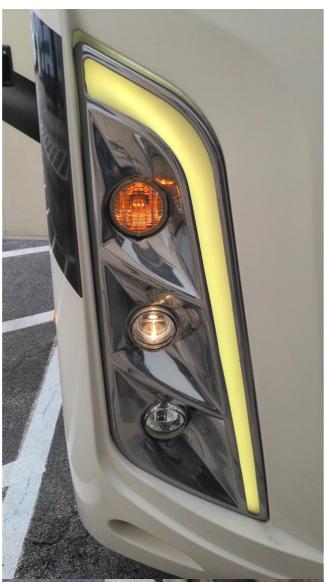
4.4 Item 1 (Picture) fog lamps

(2) Both fog light lamps illuminate acceptably and the bezels are clear.

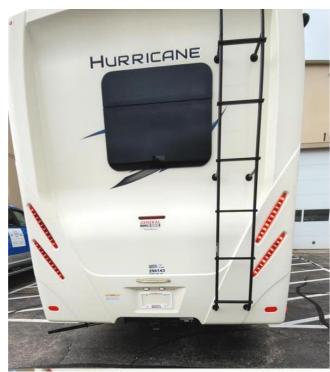
(1) The hazard lights illuminate and function acceptably.

4.5 Item 1 (Picture) hazard lights operational

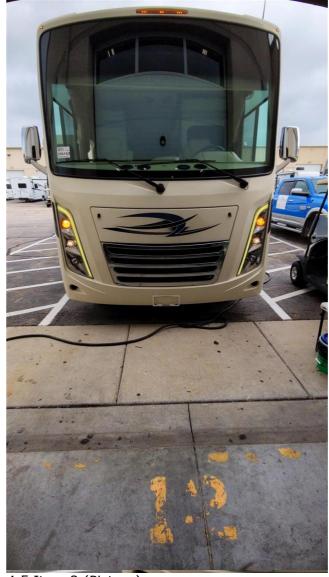
4.5 Item 2 (Picture) front hazard lights operational

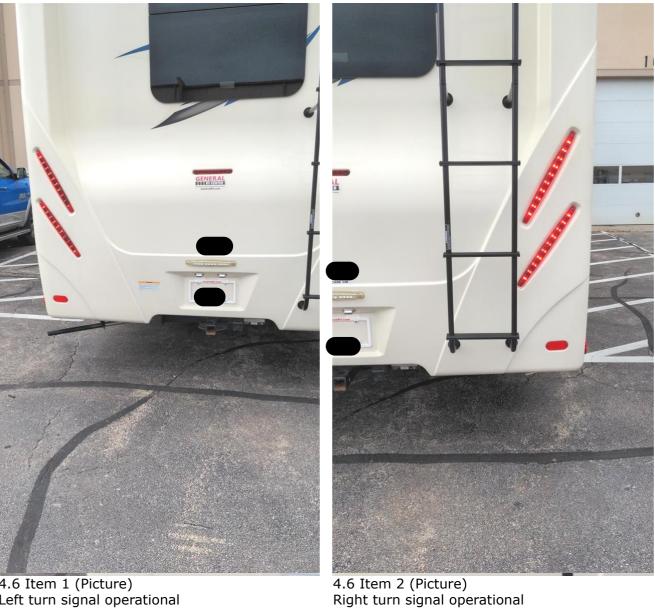
(1) The turn signals illuminate acceptably and the bezels are clear.

4.6 Item 1 (Picture) Left turn signal operational

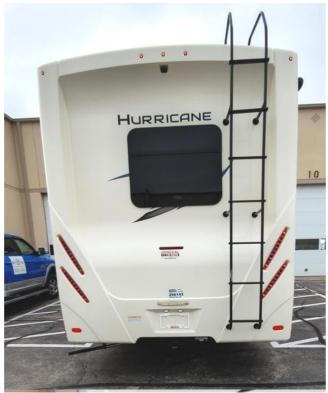
4.9 Item 1 (Picture)

(1) Both tail lights illuminate acceptably and the bezels are clear.

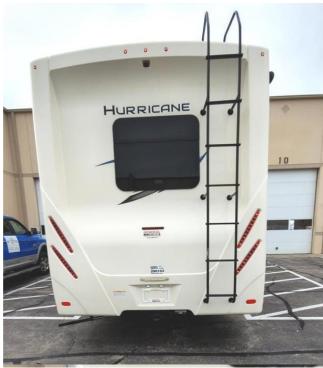
(1) The brake lights illuminate acceptably and the bezels are clear.

4.10 Item 1 (Picture) brake lights

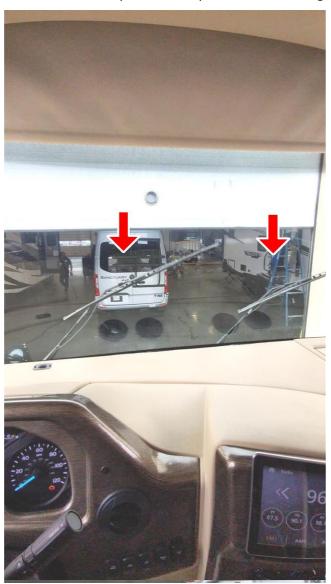
The windshield wipers were operational and in good condition.

5.3 Item 1 (Picture) windshield wipers operational

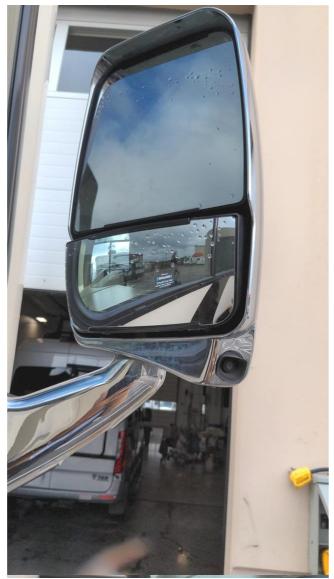
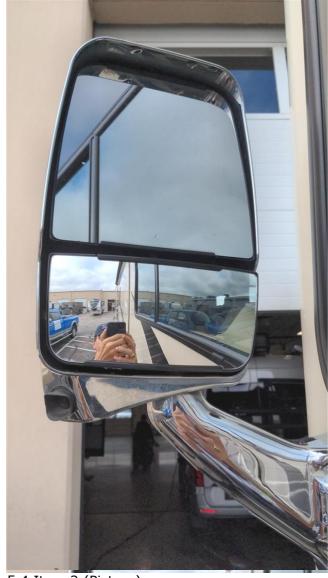
The exterior mirror housings are intact with wear consistent with the age of the RV; the mirror glass is without damage on both sides.

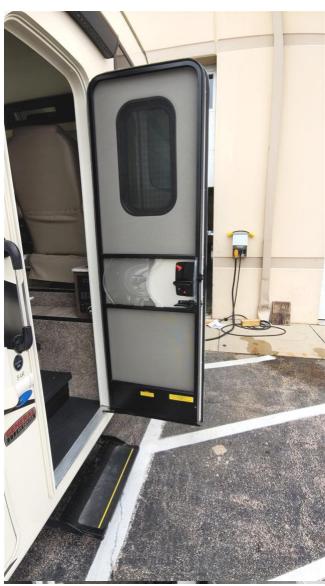
6.4 Item 2 (Picture) screen door open and attached to door

This may be a feature of the coach by design of the manufacturer, however the inspector recommends that the door mechanism be evaluated by a qualified RV technician for any issues.

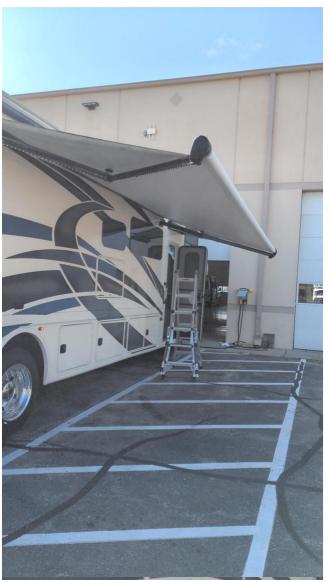
The fabric at the beginning of the awning roll is visibly discolored from prolonged contact with the awning roll mechanism.

7.0.A Item 1 (Picture) Main Awning

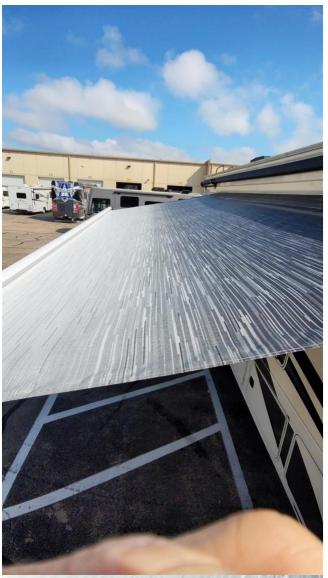
7.0.A Item 2 (Picture) awning fabric on top

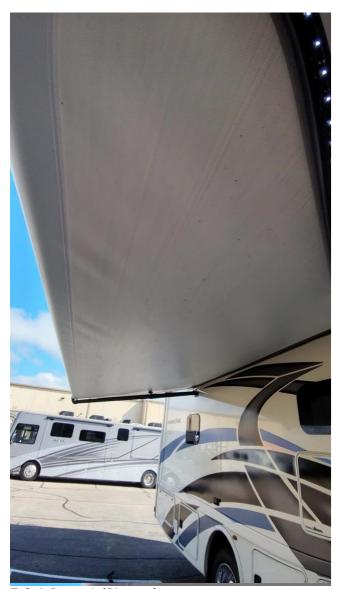
7.0.A Item 4 (Picture)
Awning fabric condition underneath

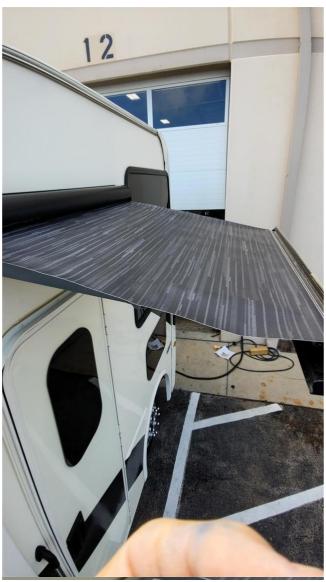
7.0.B Item 3 (Picture) top of awning fabric

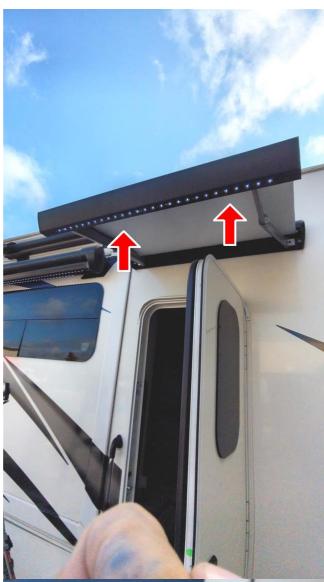
The awning lights are operational.

7.1.B Item 1 (Picture) awning lights lit

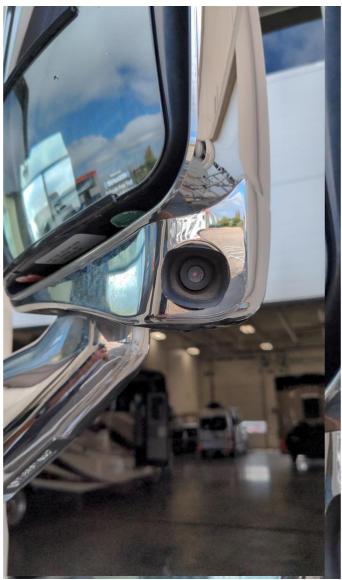
8.3 Item 1 (Picture) curbside sidewall camera

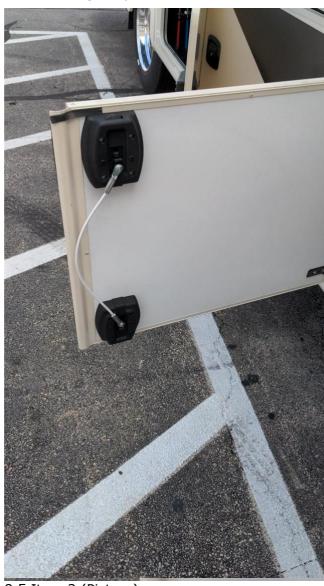
8.5 Item 3 (Picture) front cargo bay suicide door mechanism

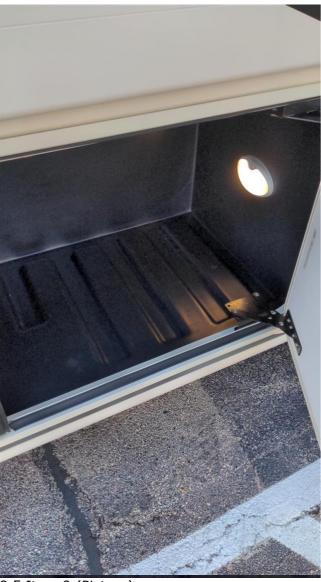
8.5 Item 9 (Picture) representative cargo Bay lamp illuminated

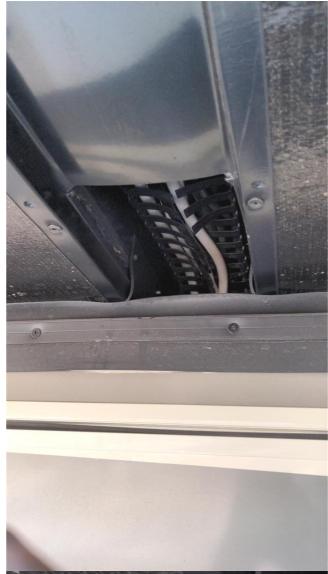
9.4 Item 2 (Picture) slide out wiring harness

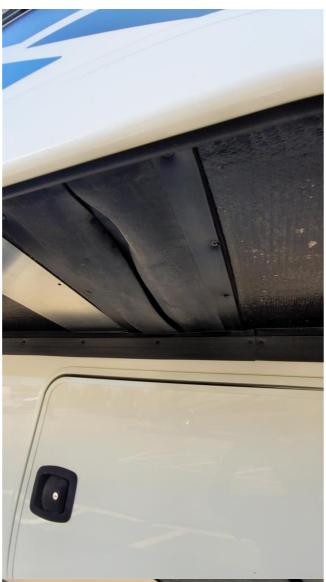
9.4 Item 3 (Picture) slide out detail 2

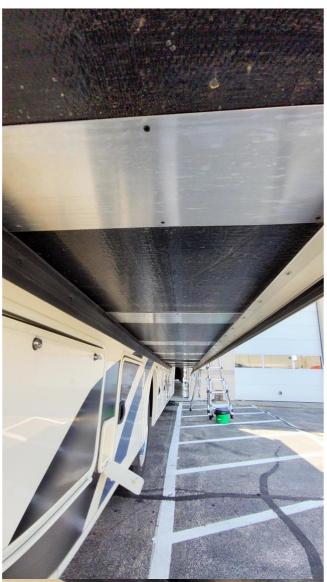
9.4 Item 4 (Picture) slide out floor

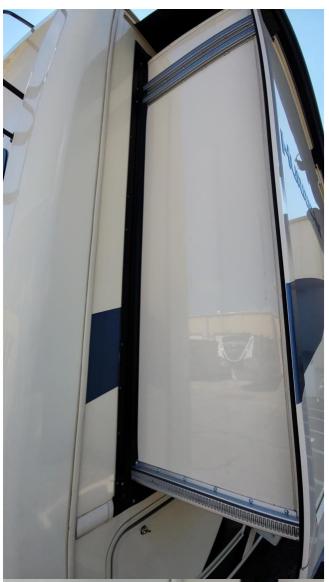
9.7 Item 3 (Picture) curbside slide out sweep

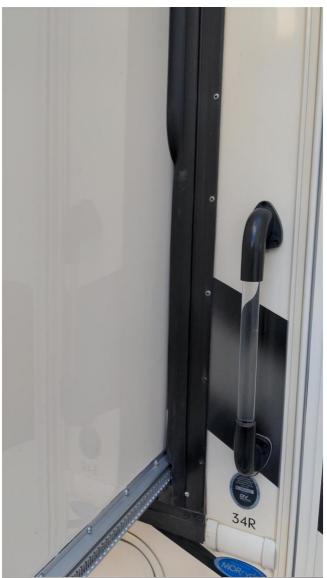
9.7 Item 4 (Picture) partially indented front curbside sweep seal

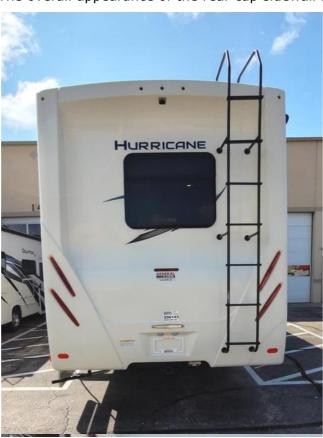
The overall appearance of the rear cap sidewall is consistent with the age of the RV.

10.0 Item 1 (Picture) rear cap overview

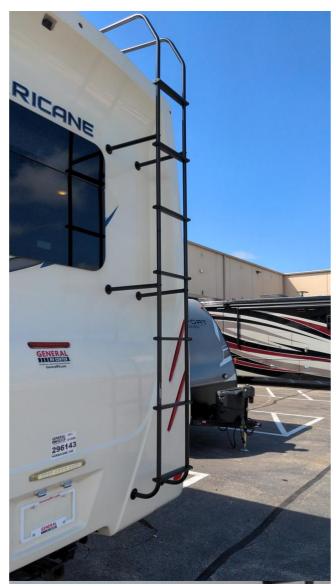
10.7 Item 1 (Picture) ladder

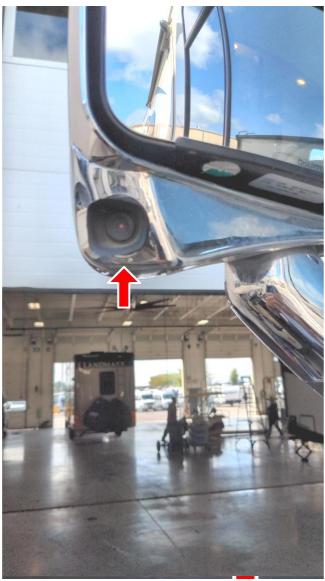
11.3 Item 1 (Picture) streetside sidewall camera

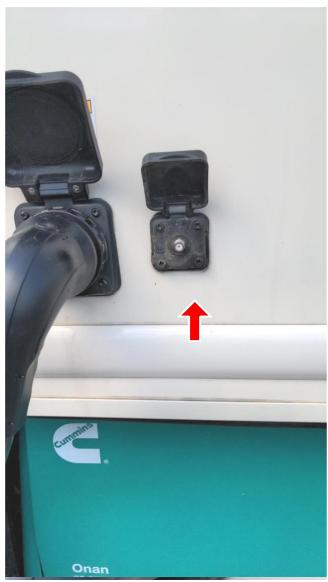
The antenna cable connection is at the rear of the street side sidewall

11.6 Item 1 (Picture) cable connection

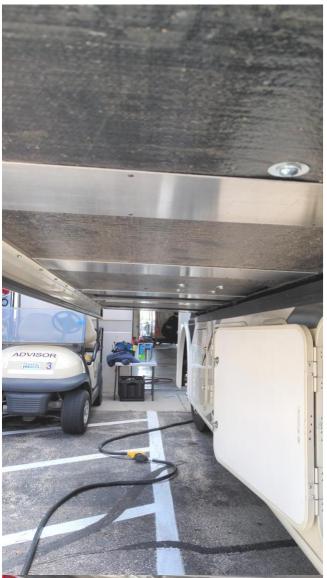
There is a small defect in the center area of the slide out floor which could be a source of water intrusion. The inspector recommends that the area be addressed by a qualified RV technician and resealed.

12.3 Item 1 (Picture) slide out floor overview

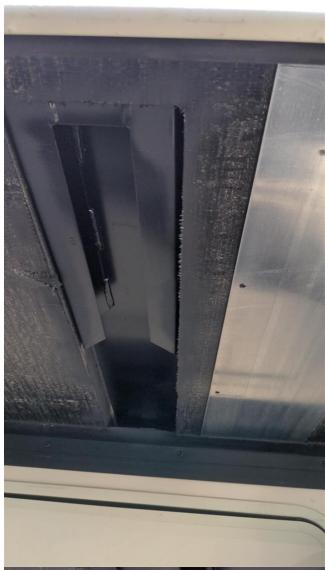
12.3 Item 3 (Picture) slide up floor detail one

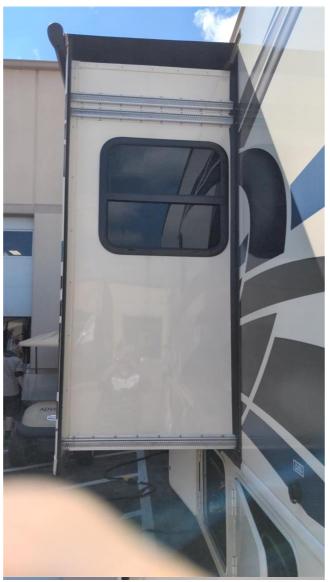
12.4 Item 1 (Picture) slide out side window

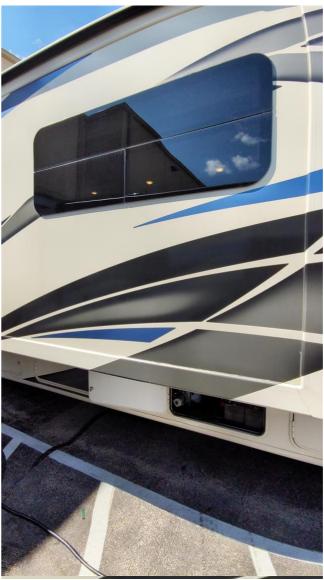
12.4 Item 2 (Picture) slide out main window

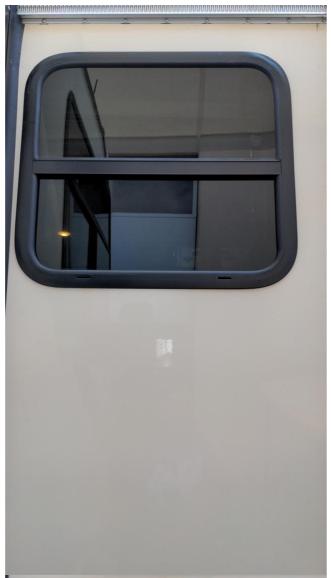
12.4 Item 3 (Picture) slide out front side window

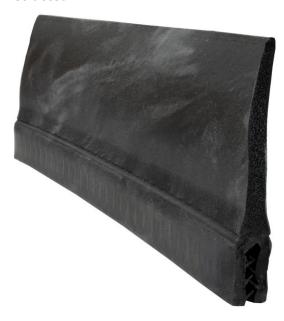
12.6 Item 1 (Picture) Typical Slideout Sweep Seal

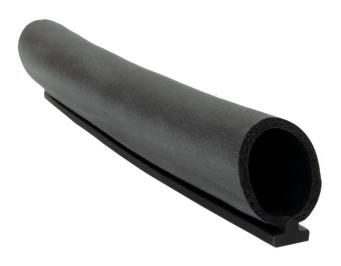
12.6 Item 2 (Picture)
Typical Slideout Bulb Seal

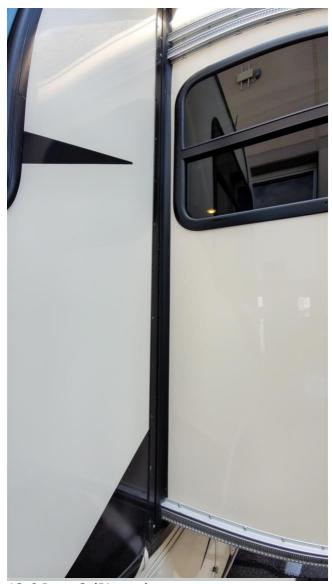
12.6 Item 3 (Picture) slide out sweep

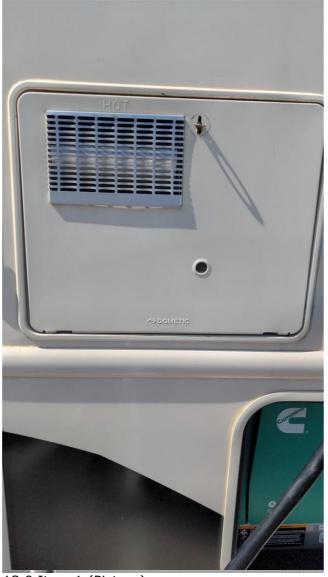
13.0 Item 1 (Picture) water heater cover closed

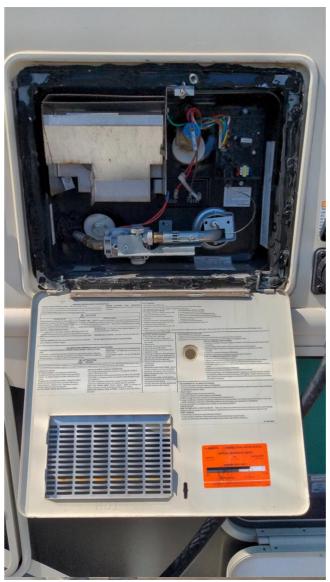
13.0 Item 2 (Picture) water heater cover open

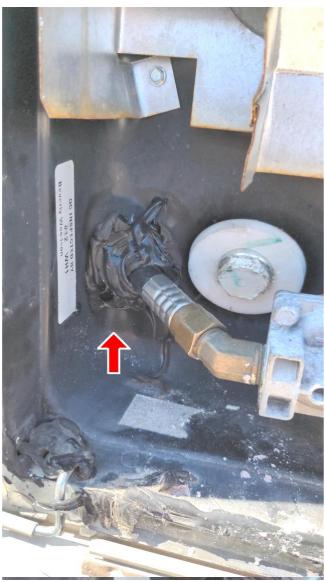
13.1 Item 1 (Picture) water heater grommet sealed

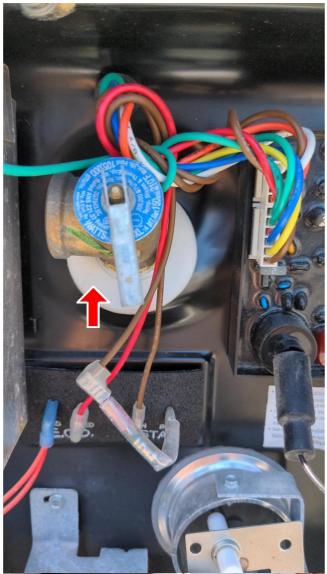
13.2 Item 1 (Picture) water heater P&T valve

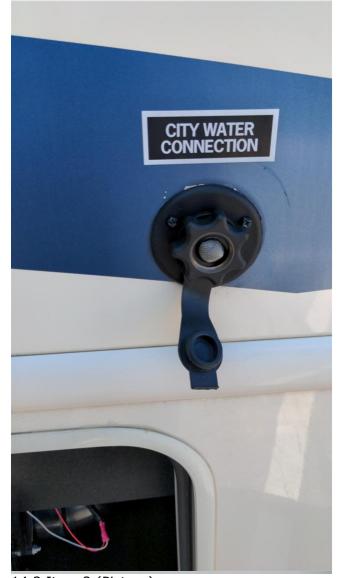
14.2 Item 2 (Picture)

While clearly labeled, the city water connection is black in color, while convention usually has it white in color. The inspector recommends the owner not confuse this inlet with the black tank flush inlet.

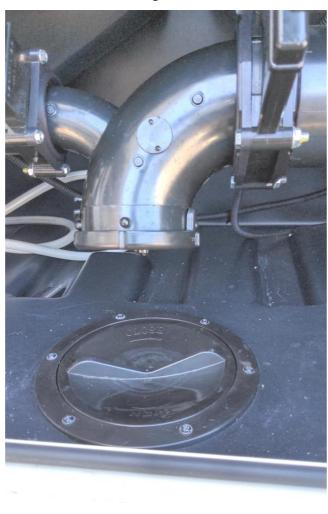
14.7 Item 1 (Picture) sewer hose fitting

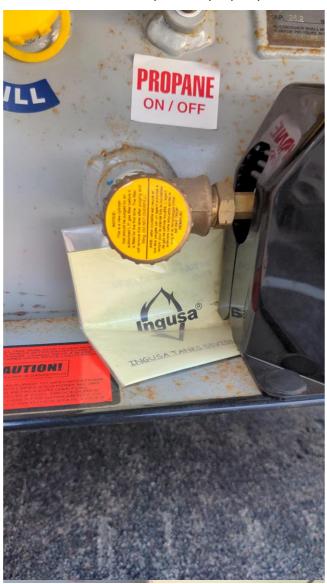
The LP shut off valve operates properly to shut off the flow of propane.

15.2 Item 1 (Picture) propane shut off valve

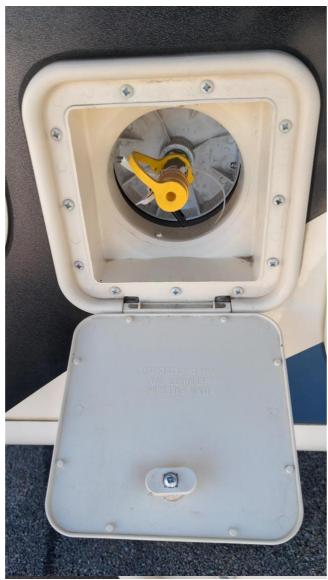
15.3 Item 1 (Picture) quick connect grill Port

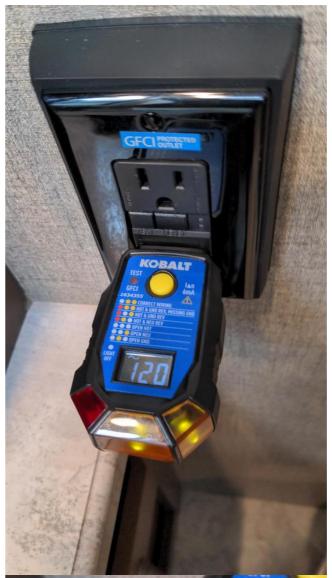
16.1 Item 2 (Picture) bathroom outlet

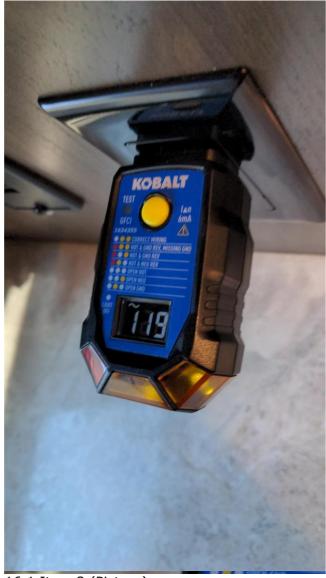
16.1 Item 3 (Picture) bedroom polarity

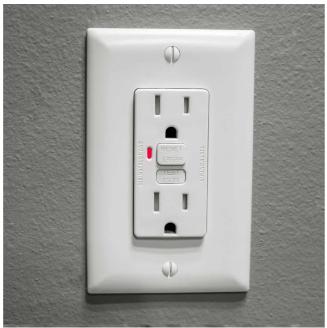
16.2 Item 1 (Picture) Typical GFCI Outlet

The GFCI receptacle(s) operate as anticipated.

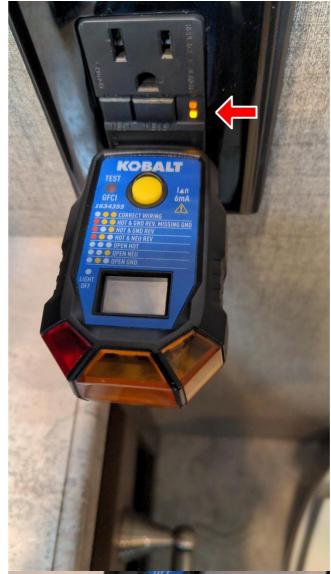
16.2 Item 2 (Picture) GFCI outlet tripped

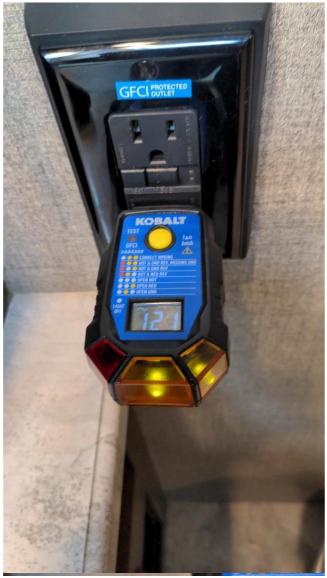
16.2 Item 3 (Picture) GFCI outlet reset

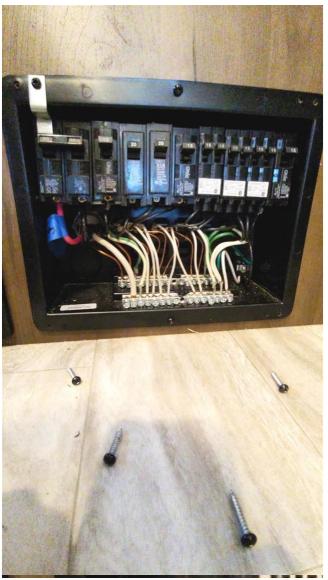
16.3 Item 2 (Picture) electrical panel box wiring

Overview of the electrical panel. The inspector recommends that the owner familiarize themselves with the electrical panel in that it is very close to the ground and can be difficult to access unless one is lying flat on the ground.

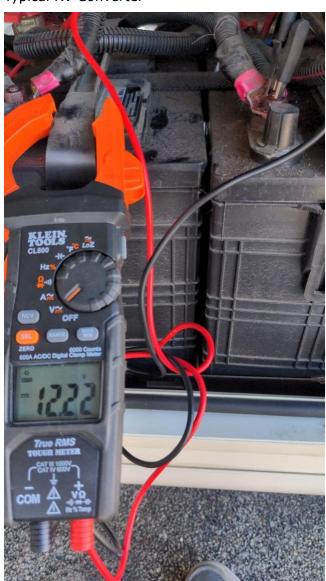
16.6 Item 2 (Picture) battery voltage external power off

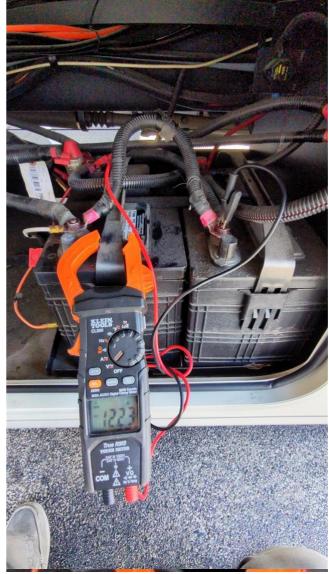
16.11 Item 2 (Picture) Coach battery voltage while on generator

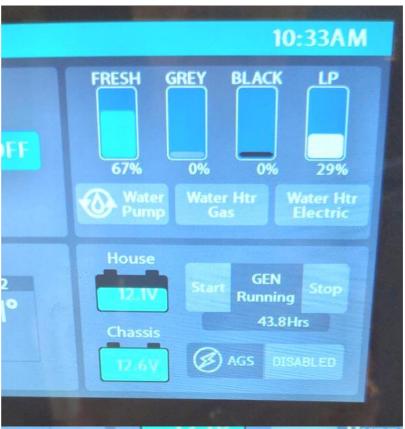
16.11 Item 3 (Picture) battery voltage confirmed at panel

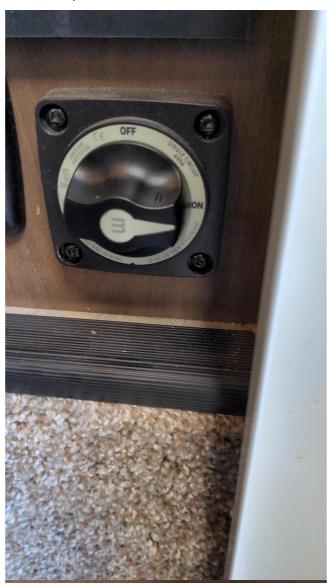
16.12 Item 1 (Picture) battery disconnect switch

The battery disconnect switch is located inside the entryway

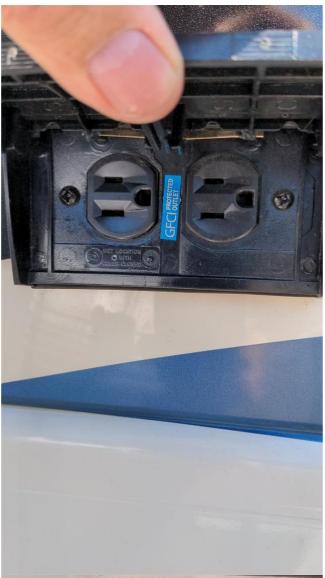
16.14 Item 1 (Picture) external 120 volt outlets

There are two external 120 volt outlets, GFCI controlled, on the curbside slide out sidewall rear.

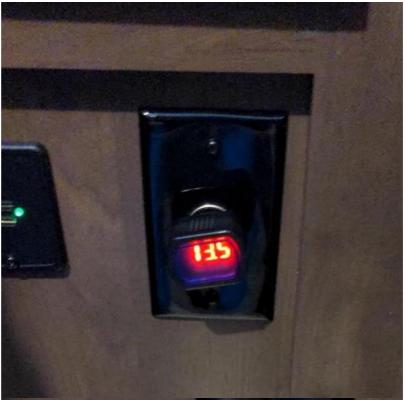
16.16 Item 2 (Picture) 12 volt receptacle voltage

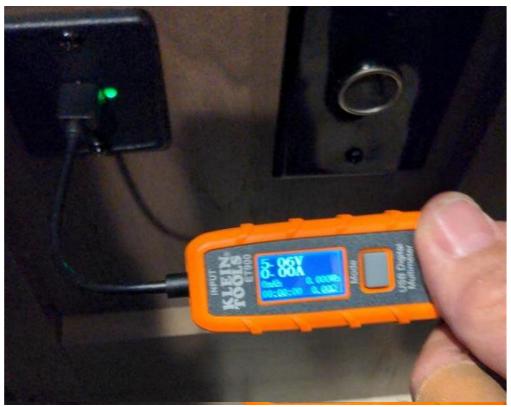
16.17 Item 2 (Picture) USB outlet voltage

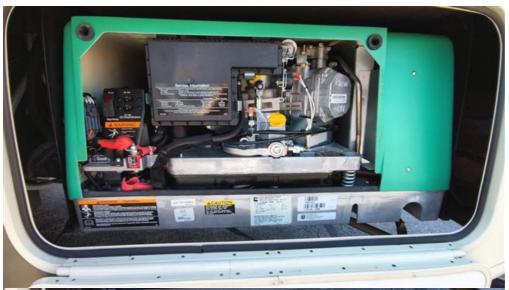
16.18 Item 2 (Picture) overview of generator

Overview of the generator. The generator electrical outlet has its rubber caps deteriorated and in lying in pieces at the bottom of the generator housing. The inspector recommends that these electrical connections be evaluated by a qualified RV technician prior to use. This is a life safety issue due to the risk of potential electrical shocks.

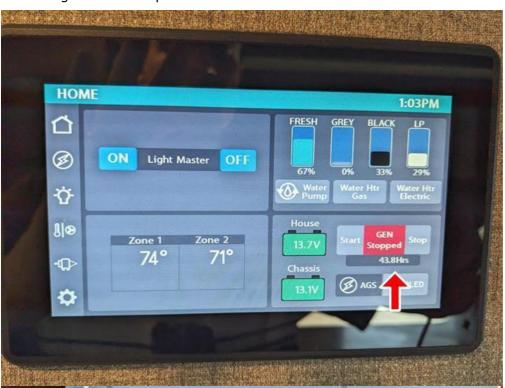
16.18 Item 5 (Picture) Generator Hours = 43.8

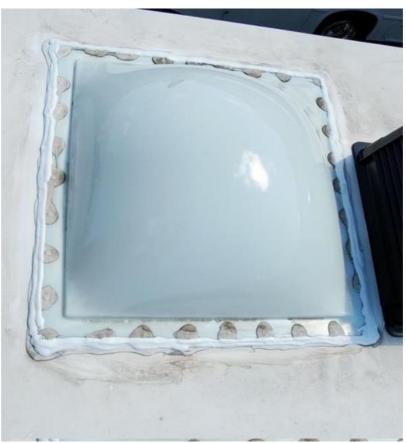
Overview of the skylight(s). The skylight has been resealed recently.

17.9 Item 1 (Picture) Resealed lap sealant

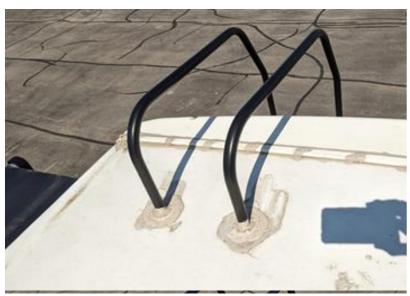
17.16 Item 1 (Picture) Ladder Mount

(2) A loose screw has been sealed into the sealant at the ladder base mount. The inspector recommends that the area be addressed by a qualified roof technician and the screw be removed and sealant be reapplied.

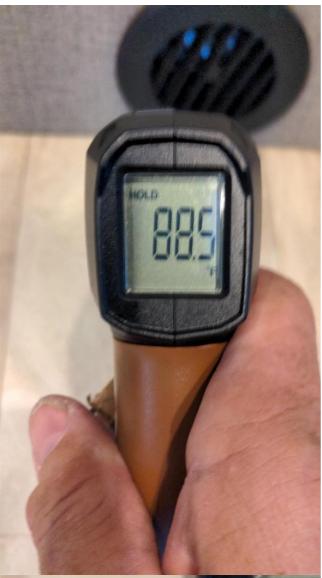
18.0 Item 1 (Picture) furnace air temperature

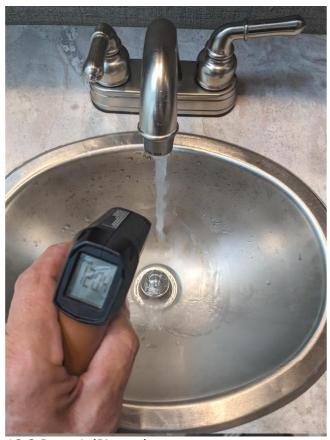
Temperature of the water coming from the water heater: 120 degrees

18.2 Item 1 (Picture) Hot water temperature

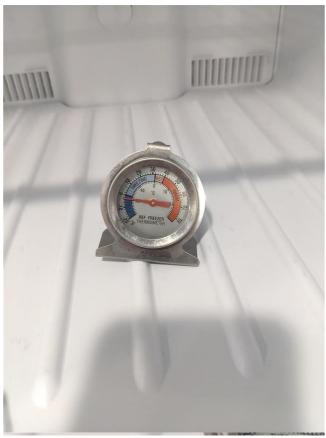
18.7 Item 1 (Picture) Freezer Zero degrees

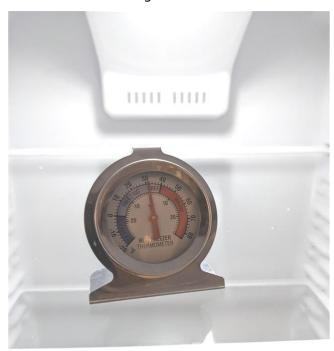
18.8 Item 1 (Picture) Refrigerator 30 degrees

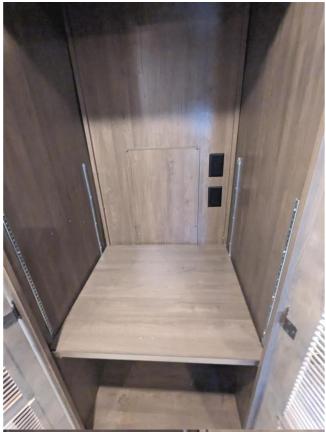
The closet outside the bathroom is plumbed for a stackable washer/dryer unit.

18.11 Item 1 (Picture) Closet plumbed for W/D

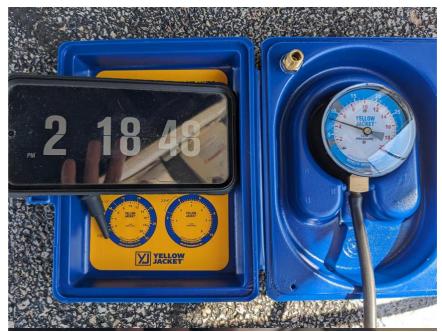
- 2:12 Begin Test: pressure is 11 in H2O
- 2:12 Bleed pressure down to 8-9 in H2O
- 2:18 Pressure held at 8-9 in H2O for > 5 minutes PASSED LP leak test

19.0 Item 3 (Picture) Hold pressure x 5 minutes

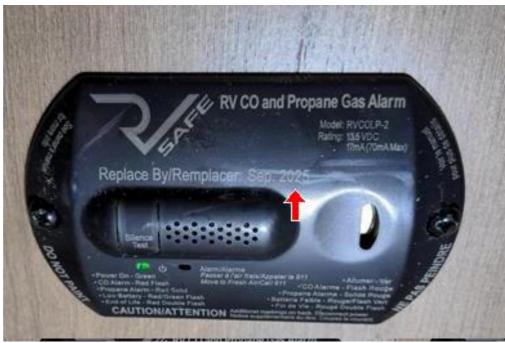
19.1 Item 1 (Picture) LP/CO detector expires September 2025

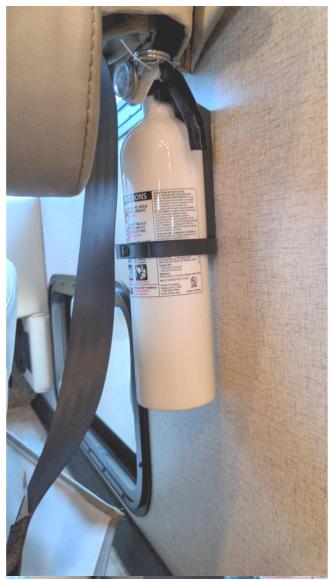
19.4 Item 1 (Picture) fire extinguisher

The fire extinguisher is less than 12 years old, shows a charged state and is properly mounted and secured.

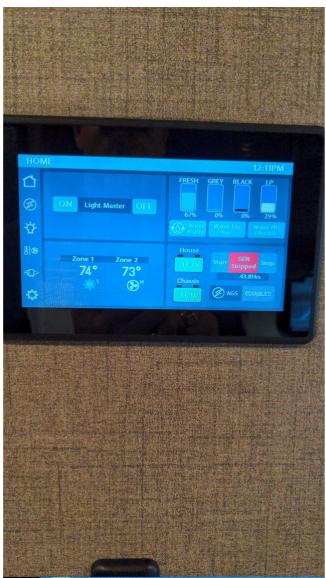
20.1 Item 1 (Picture) monitor panel

Overview of the monitor panel.

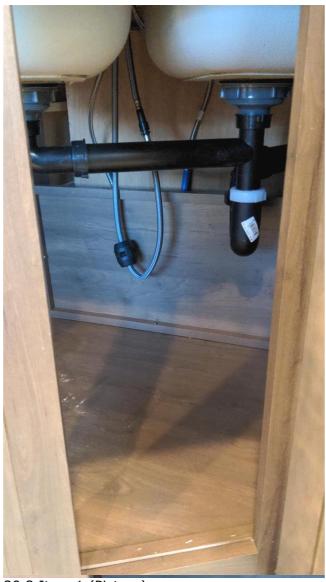
20.2 Item 1 (Picture) kitchen sink plumbing

Under sink kitchen

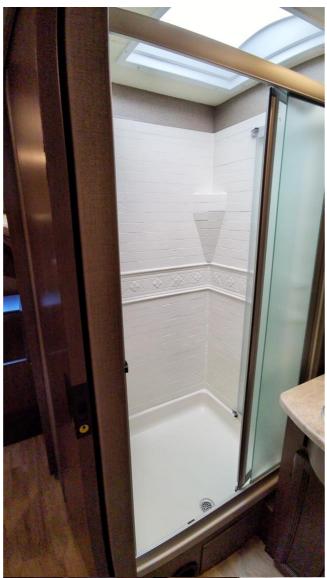
20.6 Item 1 (Picture) shower

Overview of the shower enclosure.

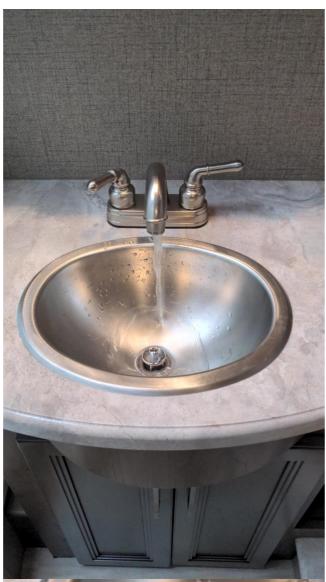
20.8 Item 1 (Picture) bathroom faucet

The bathroom faucet operates as expected.

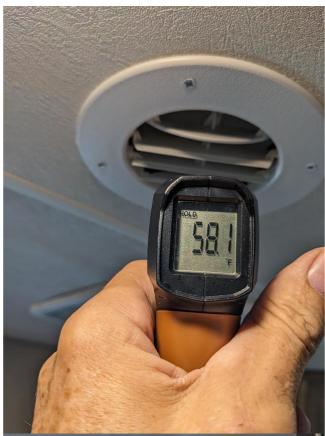
21.0.A Item 1 (Picture) AC temperature

Air conditioner overview.

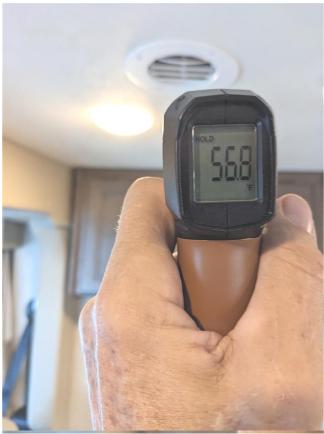
21.0.B Item 1 (Picture) AC temperature

Air conditioner overview.

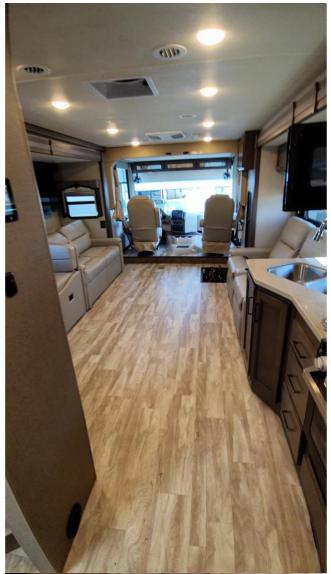
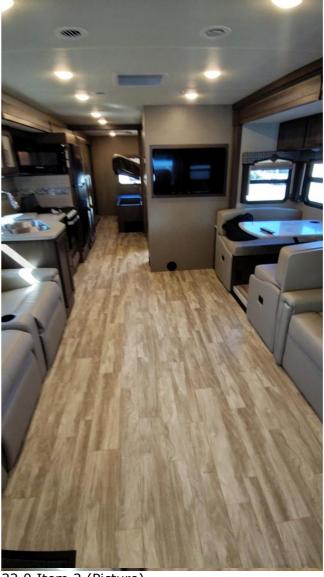
Overall the interior is in acceptable condition consistent with the age of the RV.

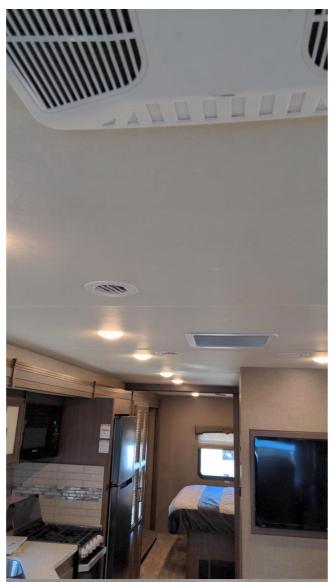
22.2 Item 1 (Picture) overview of ceiling

Overview of the Ceiling.

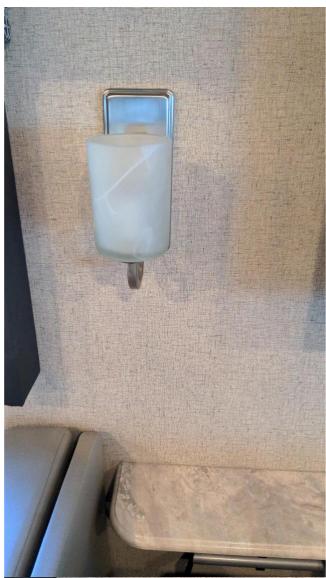
22.7 Item 1 (Picture) living area sconce

(1) Overview of the interior light(s).

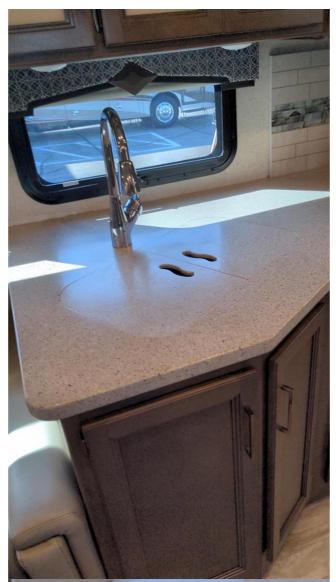
22.11 Item 1 (Picture) kitchen countertop

Overview of the countertop(s).

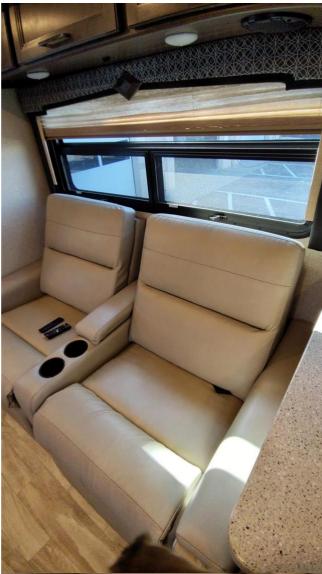
22.12 Item 1 (Picture) representative interior window

Overview of the window(s).

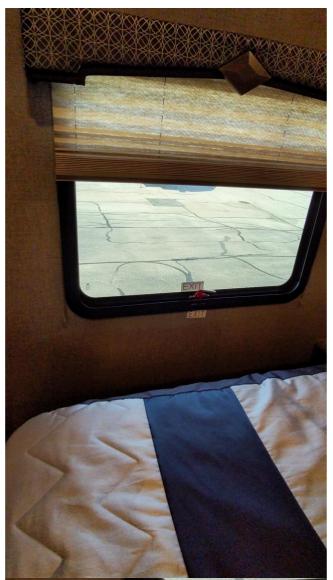
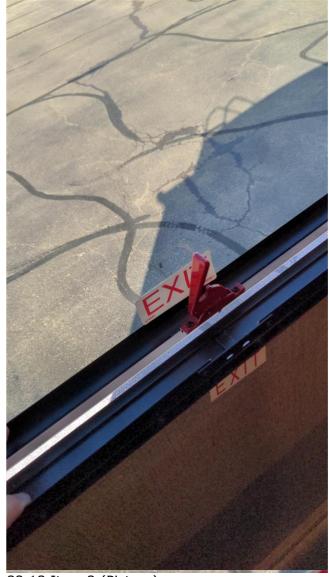
Emergency exit window is located in the extreme rear of the coach in the master bedroom

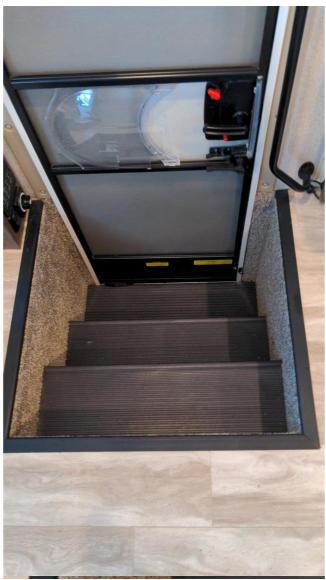
22.18 Item 1 (Picture) entry steps

Overview of the Interior steps

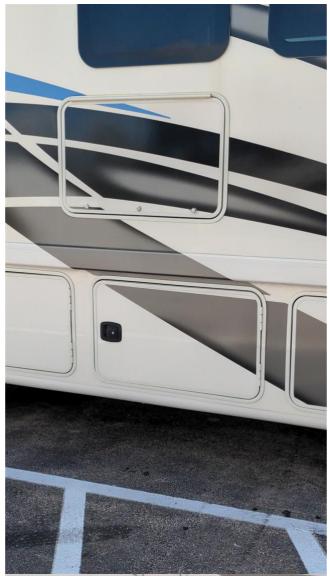
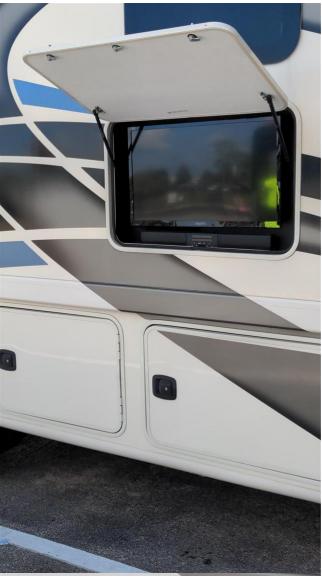
Overview of outdoor TV

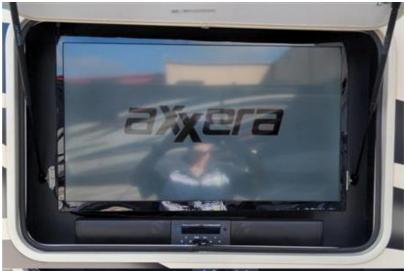
24.1.A Item 1 (Picture) outdoor TV operational

The outdoor TV operates appropriately.

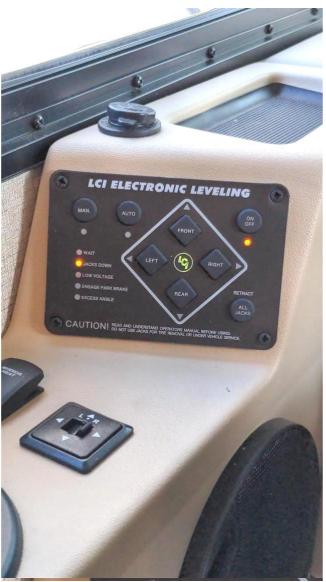
25.0 Item 1 (Picture) leveling Control pad

Overview of the leveling system control panel.

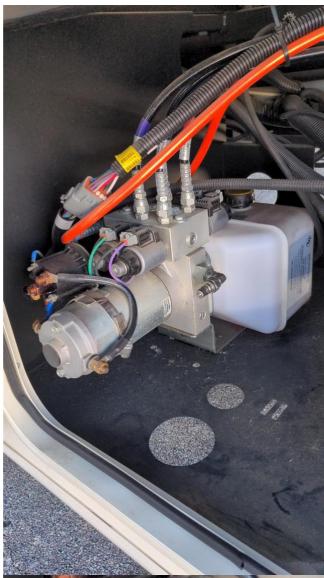
25.2 Item 1 (Picture) hydraulic pump in battery Bay

Overview of the hydraulic pump.

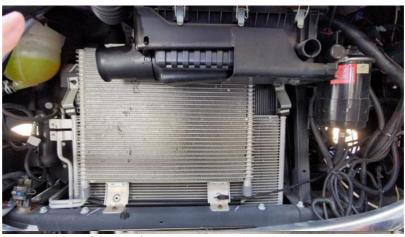
26.0 Item 1 (Picture) engine compartment

Engine Compartment Overview

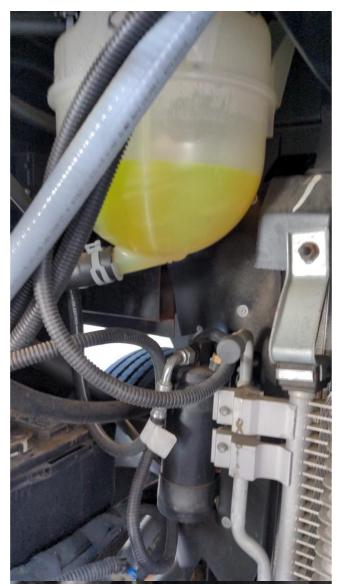
26.6 Item 1 (Picture) coolant overflow reservoir

Overview of the coolant level

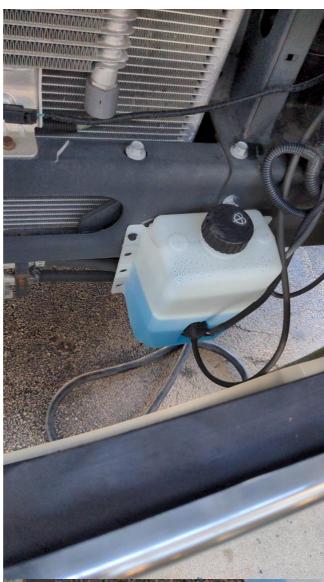
26.7 Item 1 (Picture) windshield fluid reservoir reservoir

Overview of the washer fluid level.

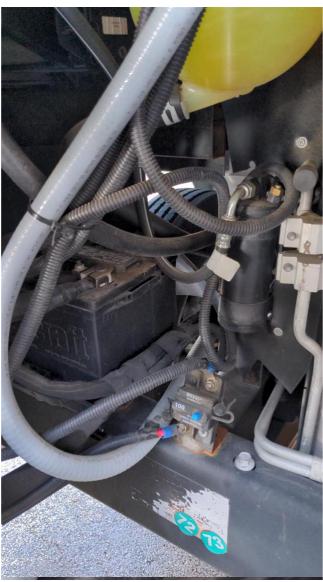
26.8 Item 1 (Picture) engine hoses

The engine hoses showed no evidence of damage or leaking.

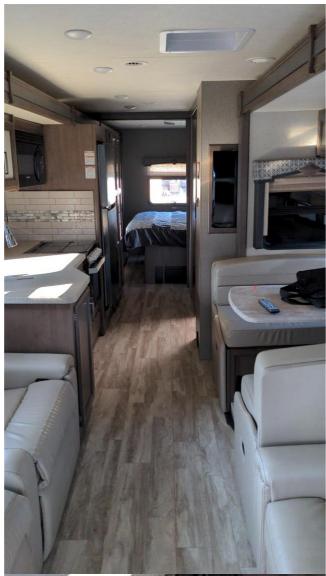
30.2 Item 1 (Picture) front to back

Overview of interior of RV at completion of inspection

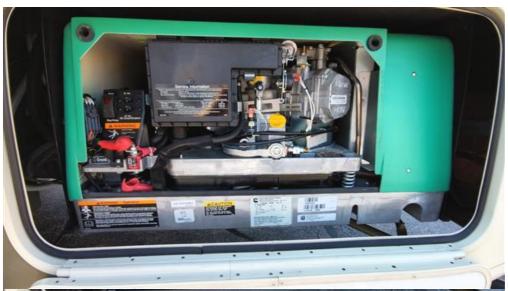
16.18 Item 2 (Picture) overview of generator

Overview of the generator. The generator electrical outlet has its rubber caps deteriorated and in lying in pieces at the bottom of the generator housing. The inspector recommends that these electrical connections be evaluated by a qualified RV technician prior to use. This is a life safety issue due to the risk of potential electrical shocks.

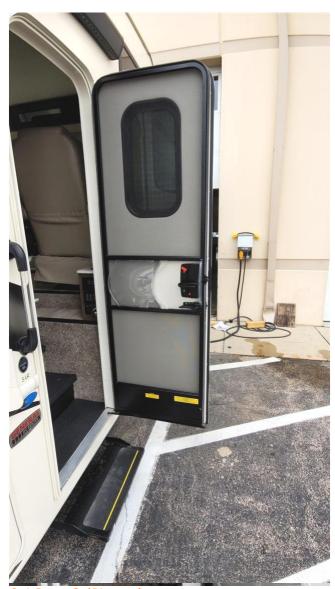
6.4 Item 2 (Picture) screen door open and attached to door

This may be a feature of the coach by design of the manufacturer, however the inspector recommends that the door mechanism be evaluated by a qualified RV technician for any issues.

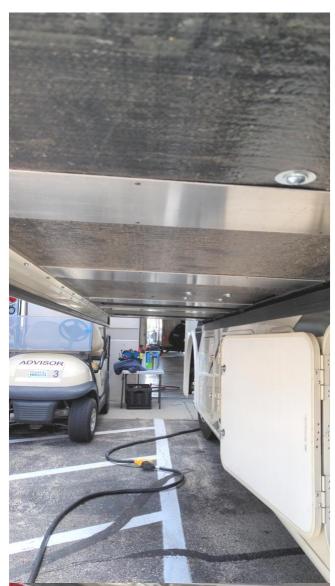
12.3 Item 1 (Picture) slide out floor overview

Overview of slide out floor

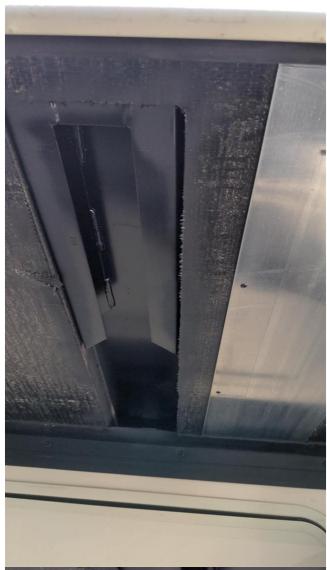
12.3 Item 3 (Picture) slide up floor detail one

There is a small defect in the center area of the slide out floor which could be a source of water intrusion. The inspector recommends that the area be addressed by a qualified RV technician and resealed.

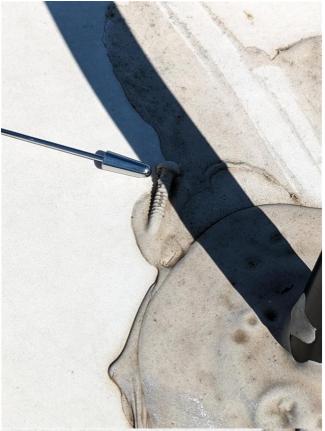
17.16 Item 2 (Picture) Screw in sealant
